SHORE EROSION STUDY

SHORELINE EROSION AND BLUFF STABILITY ALONG LAKE MICHIGAN

AND LAKE SUPERIOR SHORELINES OF WISCONSIN

OZAUKEE COUNTY

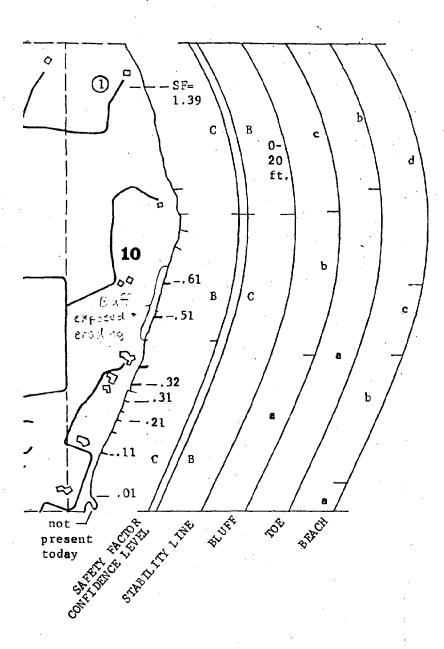
1. BLUFF	a-former lake terrace protects a bluff with approximately a 25° slope with 100% vegetation. No evidence of failure on the bluff.	b-No lake terrace, 100% vegetation on a stable bluff, 30° slope. Seawall to protect toe. no evidence of bluff failure.	c-Former lake terrace protects a bluff with approximately a 25 slope with 100% vegetation. No evidence of failure on the bluff.
2. TOE	a-toe material not visible due to shore structeres and vegeta- tion	b-sand	
3. BEACH	a30 ft. in the south grading to no beach in the north, composed of medium grained sand	b-no beach	c15 ft. medium grained sand
	d- +25 ft. medium grained sand

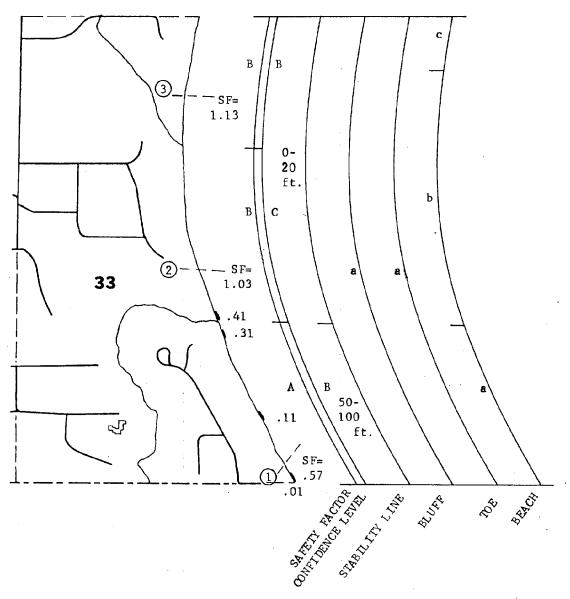
l. BLUFF	a-bluff slope approximately 40° at top with a scarp face, 30° continuously down slope from bottom of scarp. Bluff seems to be a series of minor translational faults that are sliding downslope as the toe material becomes eroded by wave action. Vegetation ranges between 10% and 90% Scarp at top of bluff continous through the section regardless of vegetation.				
2. TOE	a-slumped till and vegetation continuously through the entire section.				
3. BEACH	a-15-25 ft. beach-medium b25 ft. beach-grained sand from bluff medium grained sand medium sand, no pebbles or cobbles. ft. from water's edge. spproximately 10-15 ft. from water's edge where cobbles at water's edge. pebbles and cobbles continue to water.

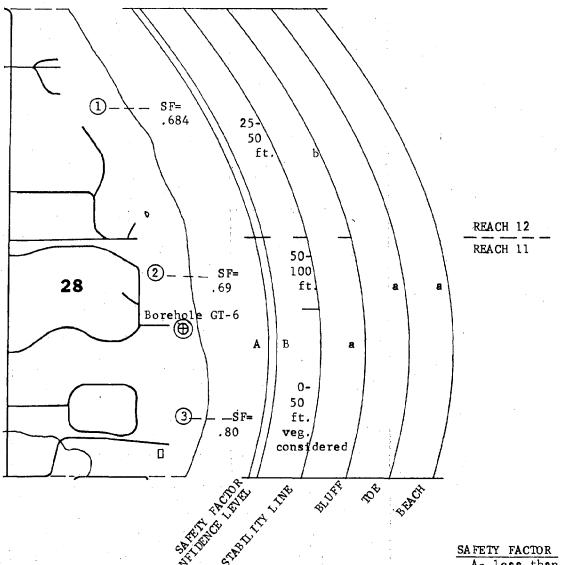
1. BLUFF	a-scarp face at the top of the bluff, translational movement (sliding, flowage and small slump blocks) all the way down the bluff face.	b-scarp face at the top of the bluff, small slumps continuously down the upper ½ of the bluff along with translational movement. The lower ½ consists of flowage, slump blocks and translational movement. The toe is being eroded by wave action.
2, TOE	a-slumped till covering in place silt	and sand, in some places till.
3. BEACH	a-15-25 ft.beach- pebbles and cobbles the toe of the bluff.	grading into medium grained sand at

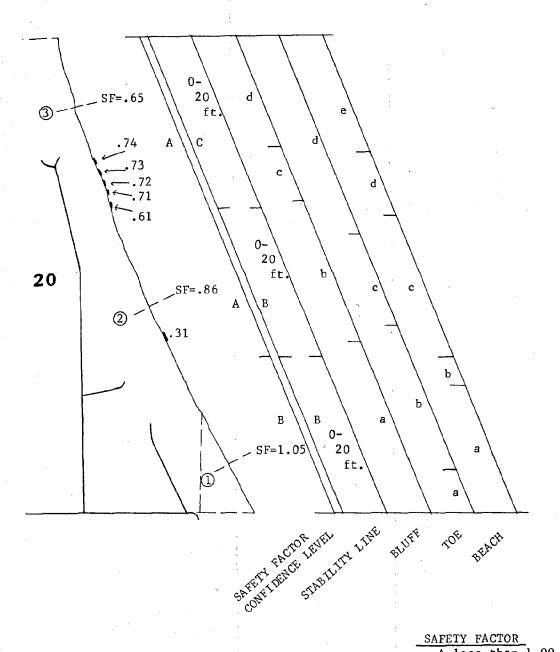
1. BLUFF	a-translational slides, toe erosion	b-translational slides on lower 3/4 of slope, rota- tion slump on upper 1/4 of slope	c-relatively stable, no recent failures	d-almost stable, several large slump blocks (slump blocks old, no recent slumping)
2. TOE	a-slide debris, red brown till and silt	b-in place silt, often with red brown till veneer 3 ft. above beach	c-in place gray clayey till	d-in place red brown till
3. ВЕАСН	a- +20 ft. sand with gravel at high wave mark e- +20 ft. sand with gravel at high wave mark	b-5 to 20 ft. sand with gravel at high wave mark	c~ +20 ft. sand with gravel at high wave mark	d5 ft. gravel

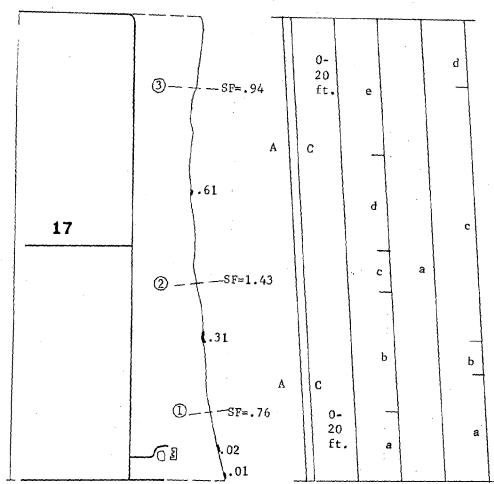
1. BLUFF	a-large deep seated slump failures, old slumps, no recent failures e-two large steps make up the slope, one old and very large slump block forms lower ½ of bluff, trans- lational slide on this block surface	·	c-large deep seated slumps	d-translational slides
2. TOE	a-toe material red-brown till		ection is slumped	l and in place
3. BEACH	a20 ft. upper ½ of beach is sand, lower ½ is gravel	b-5-20 ft. upper ½ is sand, lower ½ is gravel	c20 ft. upper ½ is sand, lower ½ is gravel	d-5-20 ft. upper ½ is sand, lower ½ is gravel

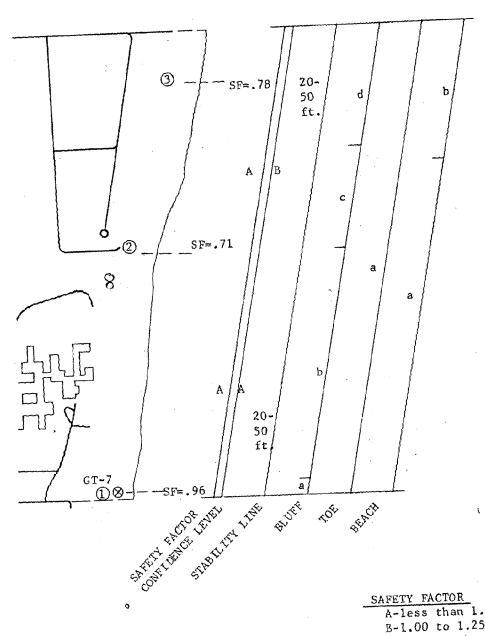
2. TOE	<pre>a-slumped sand, silt, gravel and till; can be one or a combination of the above.</pre>							
3. BEACH	approximately the water's ed	in width with bbbles extending the distance from dge to the toe; d sand extends to	b-beach 15-25 ft. in width, pebbles and cobbles extend ½ the distance from water's edge to the toe, medium grained sand the remaining distance.

4. STRUCTUR	ES- none this se	ction.

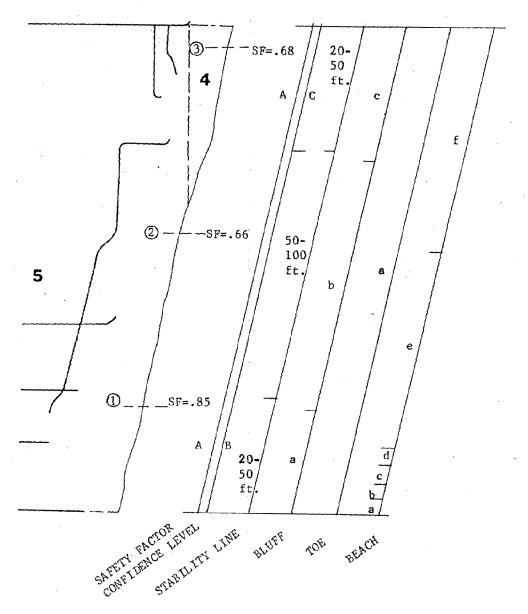
3. ВЕАСН	a-15-25 ft. in width, ½ gravel and pebbles at water's edge inward with ½ medium grained sand to toe of bluff	b-15-25 ft. in width, ½ gravel and pebbles from water's edge inward with 3/4 medium grained sand.	c25 ft. beach, 첫 gravel, 첫 sand to toe	d-20 ft. beach, all gravel		
	e-15-25 ft. beach, ½ gravel and pebbles from water's edge; ½ medium grained sand to toe	f-0-15 ft., ½ pebbles and cobbles, ½ medium grained sand

4. STRUCTUR	ES- none

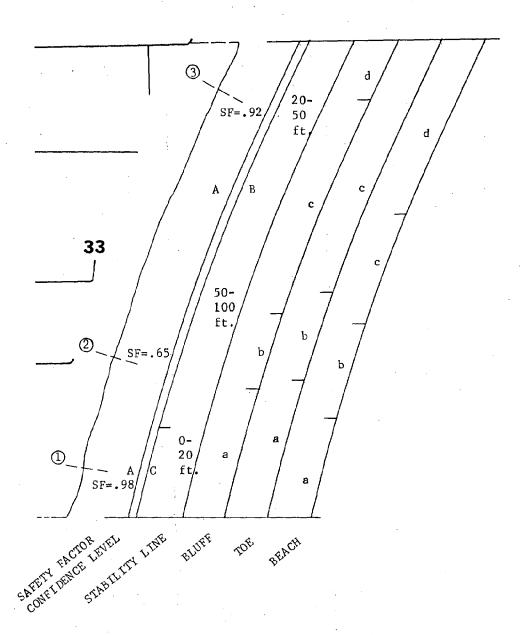
1. BLUFF	a-major deep seated slumping	b-shallow slumps and many slides.	c-major deep seated slumping	d-shallow slumping, many slides
2. TOE	a-slumped till	b-slumped till, silt and sand	c-slumped till	
3. BEACH	a- +20 ft. upper 2/3 sand, lower 2/3 pebbles and cobbles	b-5 to 20 ft. sand and gravel	c- +20 ft. sand on upper ½, gravel on lower ½	d-5 to 20 ft. sand and gravel

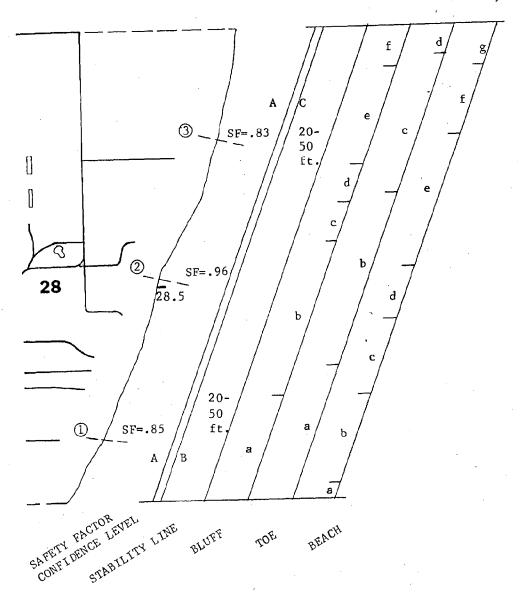
1. BLUFF	a-translational slide, rapid toe erosion f-old slumping	b-major deep seated slump blocks (old)		d-slumping (recent) shallow	e-translational slides
2. TOE	a-in place lacustrine silt and clay	b-slumped till and silt and sand	c-in place silt and clay (lacustrine)	d-slumped till and silt	
3. BEACH	a5 ft. gravel and broken trees	b- +20 ft. sand with gravel at water line	c-5 to 20 ft. upper 1/3 sand ,1ower 2/3 gravel	d- + 20 ft. upper ½ sand,lower ½ gravel	e-5 to 2 0 ft. sa nd
	f5 ft. gravel	g-5 to 20 ft. sand

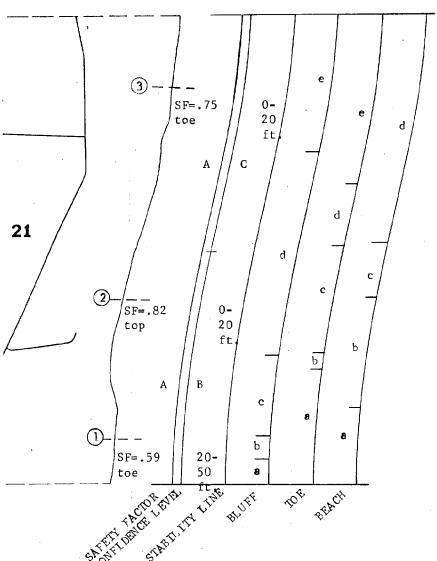
3. BEACH	a-10-20 ft. cobbles and pebbles from water's edge, ½ dis- tance to toe of bluff, medium grained sand to toe	few cobbles, pebbles and gravel	c-15-25 ft. pebbles, cobbles,gravel from water's edge ½ dis- tance to toe of bluff, medium grained sand to toe.	d-10-20 ft. intermixed pebbles, cobbles, gravel

4. STRUCT	TURES- none			·

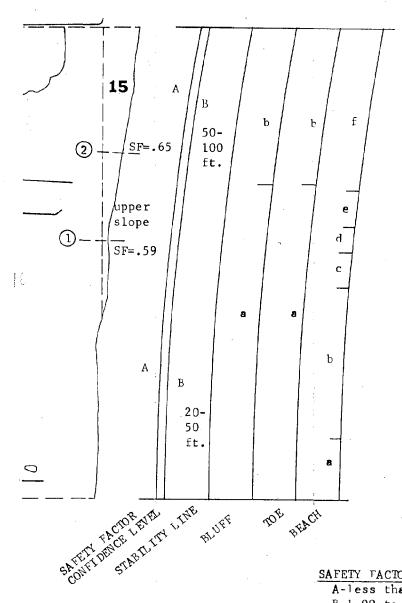
1. BLU	slumping zo	seated but older ne,no recent any large size.	b-translatio toe erosio	nal slides, rapid n
2. TOE		a-slumped red-brown till with sand and silt mixed in.		ill (intermediate) with brown till flow veneer
3 BEA	CH a5 ft., pebbles	b20 ft. upper % sand lower % pebbles	c-5 to 20 ft. pebbles	d20 ft.mostly pebble beach
	e-5 to 2 0 ft. pebbles	b20 ft. upper 1/3 sand, lower 2/3 pebbles		
4. STR	UCTURES- none

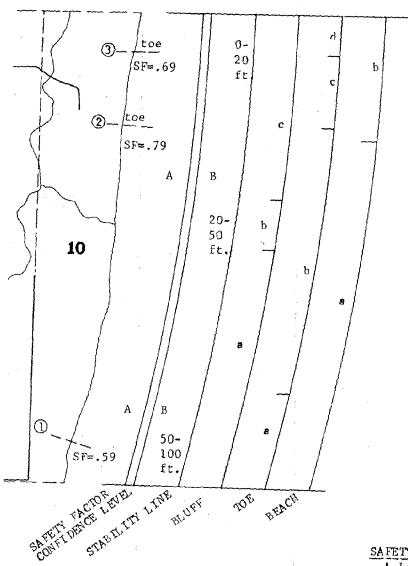
. Morr	slides due to rapid toe erosion		c-translational slope failures	
2. TO E	a-red brown till, slumped	b-in place silt and lacustrine clays	c-in place intermediate till	d-slumped red-brown till and in place intermediate till
3. ВЕАСН	a-greater than 20 ft. upper 1/2 sand, lower 1/2 pebbles		b-greater than sand cobb	20 ft., mix of oles.

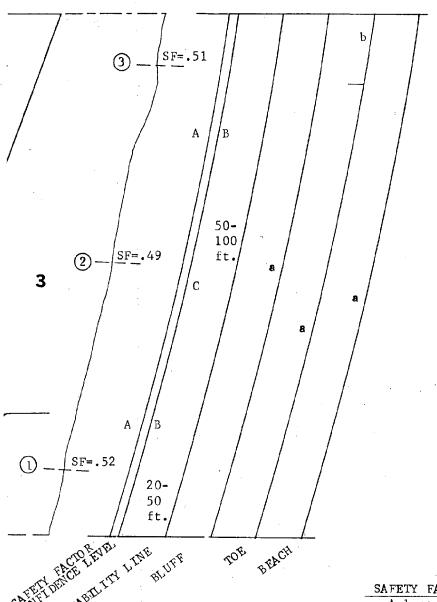
1. BLUFF	at the locations of the draina Vegetation is sparse throughou locations of the escarpments. translational movement of mate	t the section, except at the Bluff failure seems to be rial aided by groundwater sapping ghout the section. Severe wave
2. TOE	<pre>a-medium grained sand with flow till(red-brown) covering in places.</pre>	b-blue-gray till with red-brown flow till covering in places.
3. BEACH		, cobbles and gravel at the water's ed sand which continues to the toe

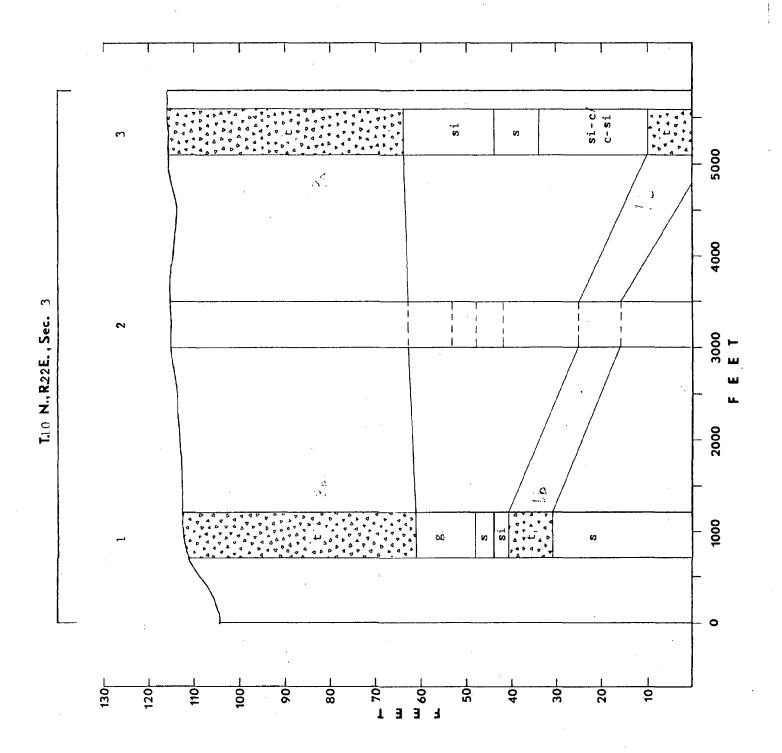
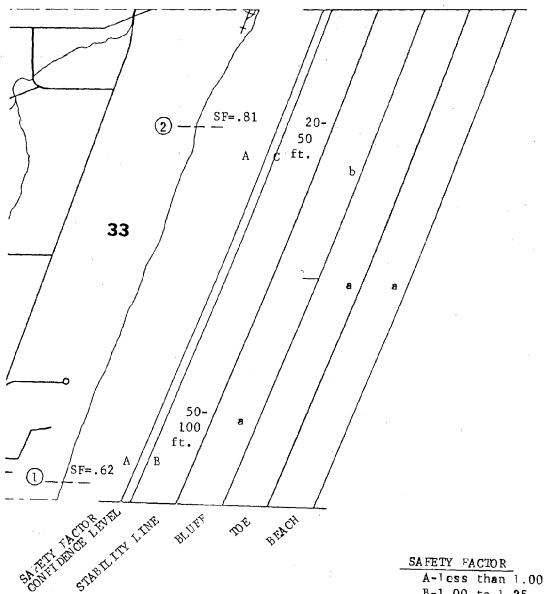
1. BLUFF	a-unstable bluff,7 drainage escarpments, translational failures of material, minimal vegetation, most areas no vegetation at all. 40° slope with excessive undercutting of toe material by wave action. Two major seeps continuously through the stretch, failure scarp at top of bluff.	b-unstable bluff, rotational slumping of material 40% vegetative cover for most of stretch. Slump scarps at top of the bluff continuously through stretch. Toe material is slumped red-brown till, excessive undermining of the toe by wave action.	
2. TO E	a-red-brown clayey till over blue-gray silty till or over stratified silty clay.		
3. ВЕАСН	a-beach width 20-30 ft. with intermixed pebbles and sand extending continuously from the water's edge to the toe of the bluff.

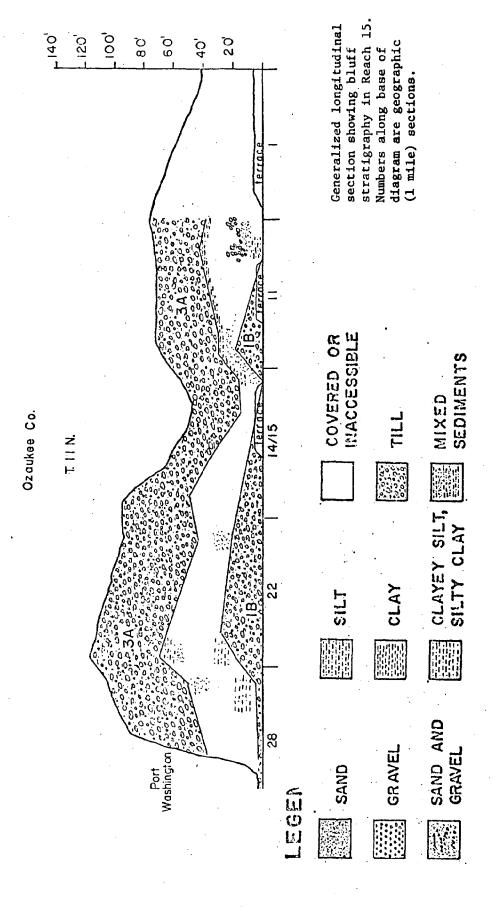
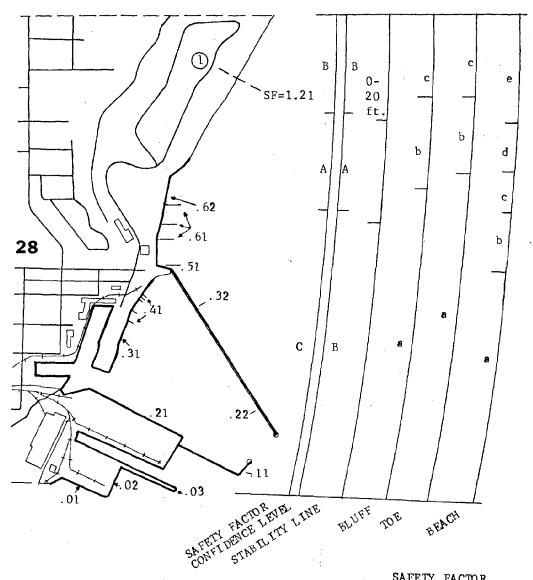
1. BLUFF	a-completely protected by jetty, sea- walls and revetment	b-very rapid erosion, very steep slumping planes and slides.	c-unstable, slumping and slides of a block torn from upper slopes	
2. TOE	a-slumped red-brown silty till	b-red-brown silty till slide debris and in place gray pebbly, cobbly till		
3. BEACH	a-no beach seawalls, jetty, revetment	b-sand, 15 ft. wide	c-revetment, (sewage treatment plant)	d-sand, 5 to 20 ft.
	e-cobbles 5 to 2 0 ft.	,	·

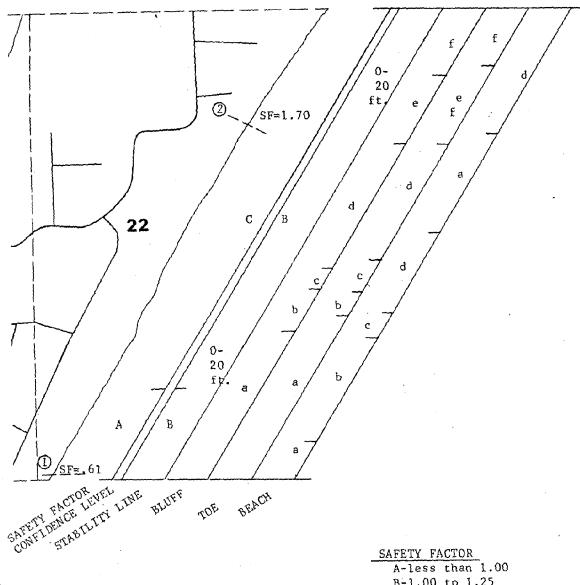
1. BLUFF				
1. BLUFF	a-shallow translational slides on lower slope slumping on upper slope	b-almost stable, subject to failure translational slides	c-several translational slides	d-relatively stable,no recent failures
	e-shallow translational slides	f-bluff almost stable, erosion caused by drainage system		
2. TOE	a-red-brown till slide debris	b-not visible	c-red-brown till slide debris	d-not visible, in places a sand terrace is found
	e-red-brown till slide debris	f-sand terrace over bluff toe		
3. BEACH	a-5 to 15 ft. cobbles	b-20 to 25 ft. sand	c-5 to 20 ft. sand and cobbles	d-very wide +30 ft. sand with gravel (pebbles) at water line
	e- +70 ft. sand with gravel (pebbles) at water line

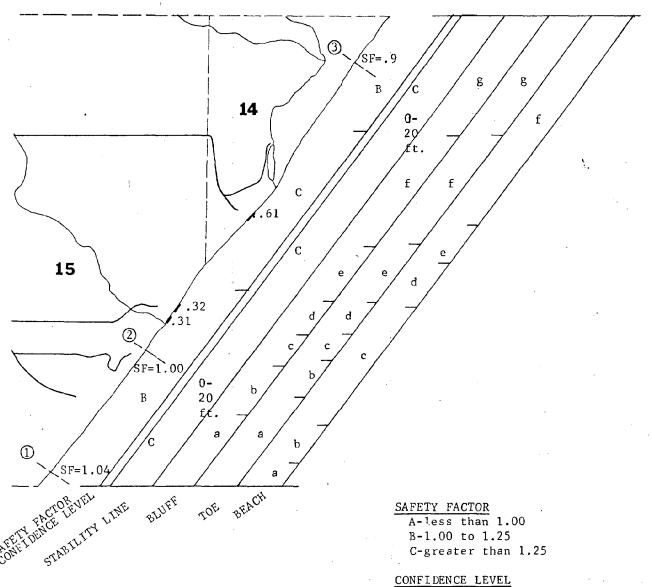
1. BLUFF	a-shallow translational slides	b-relatively stable, no recent failures. Steep slope and narrow beach make future stability doubtful.	c-shallow translational slides	d-small terrace
	e-no bluff or terrace, gentle rise	f-level sand terrace with gentle rise beyond	g-low bluff subject to translational slides	
2. TOE	a-red-brown till slide debris	b-not visible, most likely in place gray pebble, cobble till	c-red-brown till slide debris	d-sand terrace
	e-sandy silt in place	f-sand terrace	g-sand in place	
3. ВЕАСН	a-less than 20 ft. sand	b-25 ft. cobbles and pebbles	c-5 to 20 ft. cobbles and pebbles	d-5 to 15 ft. cobble and pebbles
	e-15 ft. sand	f-5 to 20 ft. cobbles and pebbles

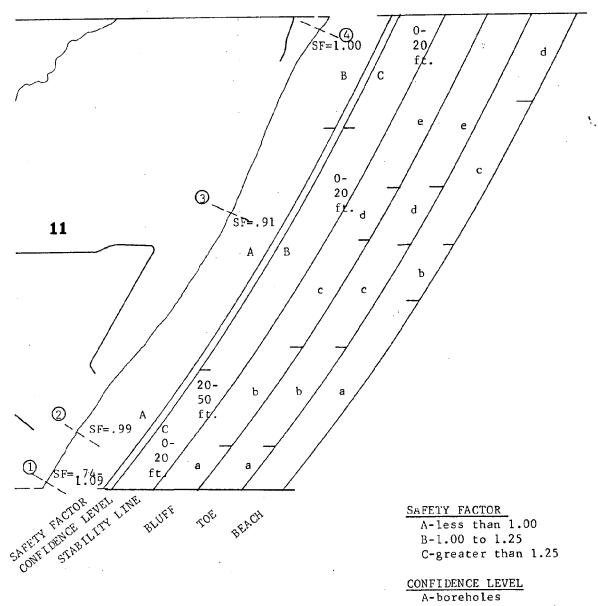
1. BLUFF	a-relatively stable,no recent failures	b-shallow translational slides	c-terrace protects a relatively stable slope no recent failures	d-shallow translational slides
	e-relatively stable, no recent failures, subject to rapid future toe erosion			
2. TOE	<pre>a-in place but unknown, sand most probable e-in place sand</pre>	b-red-brown till slide debris	c-small sand terrace	d-red-brown till slide debris
3. ВЕАСН	a-5to 15 ft. cobbles and pebbles	b-about 20 ft. pebble and cobble	c-5 to 15 ft. cobbles and pebbles	d-20 ft. widening to 30 ft. at end of section, pebbles and cobbles
4. STRUCTURES-none this section

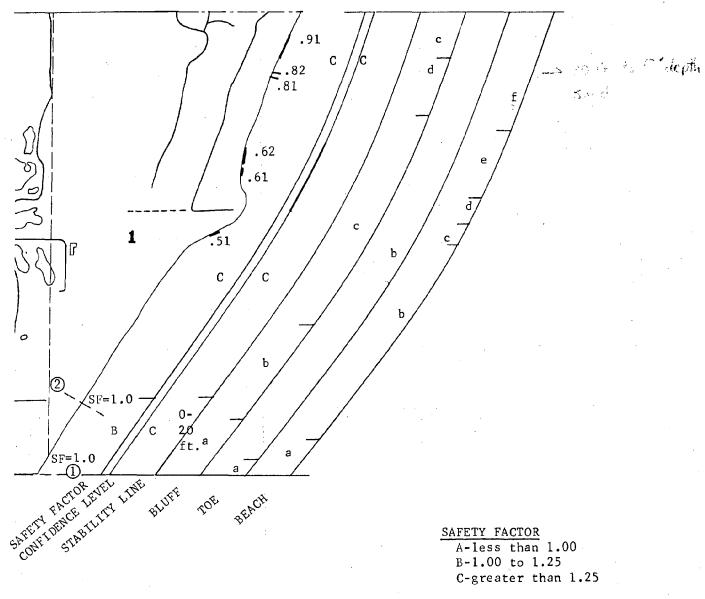
1. BLUFF	a-relatively stable, no recent failures	b- bluff 65 ft. high,constar 30° slope angle, 100% vegetation- small to large trees	nt no failures bluff pro-	gradual slope 100% vegetation-
2. TO E	a-red-brown till slide debris	b-medium grained buff sand	·	
3. BEACH	a-less than 20 ft. cobbles and pebbles	b-5 to 20 ft. cobbles and pebbles	c-5 to 20 ft. very angular cobbles of bedrock	d-5 to 20 ft. clean bedrock shelf
	e-less than 20 ft. sand and pebbles	. 1
